# TEST REPORT

Report No: 2018110K19140  
Product: EEL-PRO  
Type: -  
Applicant: Kunshan Reention Electrical and  
Mechanical Co.,Ltd

Product Name : EEL-PRO  
Product Type: -  
Quantity: 1 pcs  
Applicant: Kunshan Reention Electrical and Mechanical Co.,Ltd  
Address: NO.350yanqiao bang road, Kunshan City, Jiangsu Province, 215333,  
China.  
Manufacturer: Kunshan Reention Electrical and Mechanical Co.,Ltd  
Test Item: IP Code Test(IPX4)  
Reference Standard: GB/T 4208-2017  
Deviation : -  
Sample Receive Date: 2018/11/23  
Test Date: 2018/11/28  
Test Result: There was no water in the sample after test.  
Test Site: East Taihu Technology and Finance City, No.1368 Wuzhong Dadao Rd.,  
Wuzhong Economic Development Zone, Suzhou, Jiangsu.  
Remark: -

## 1 IP Code Test(IPX4)

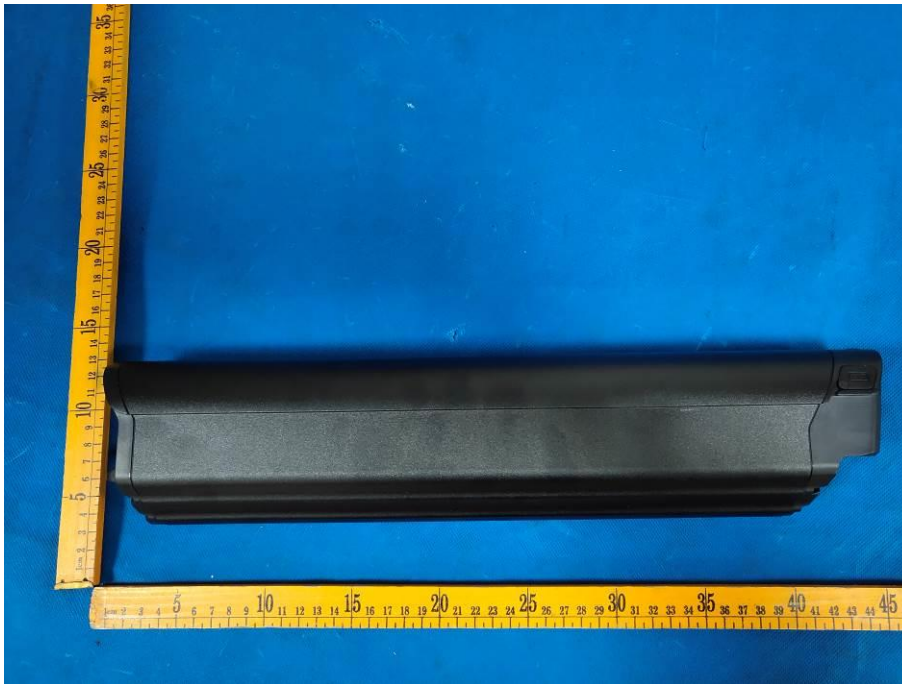
Test sample

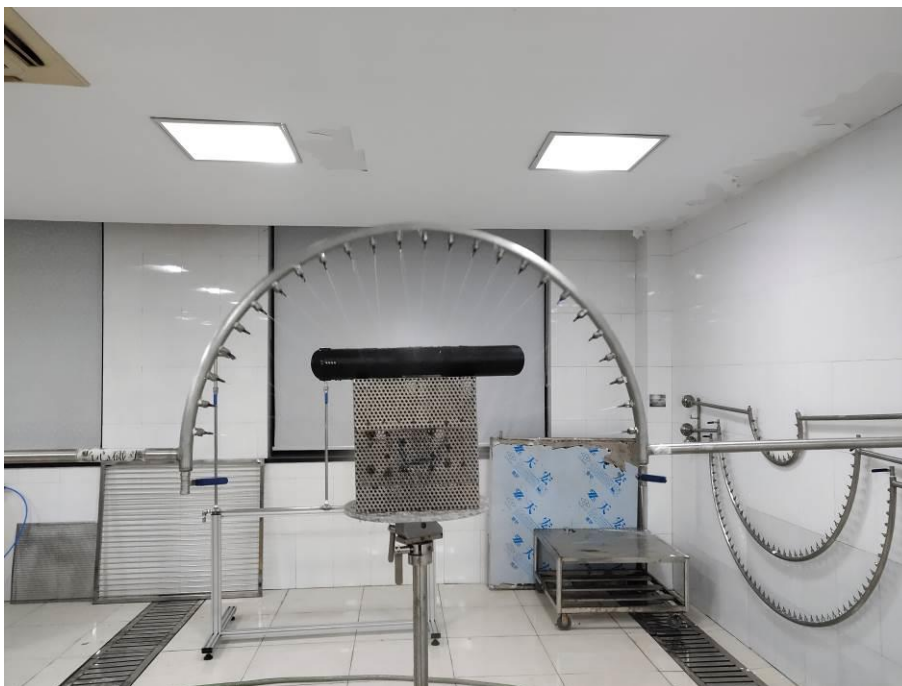
During test-IPX4

IPX4: The tube is caused to oscillate through an angle of almost 360°, 180° on either side of the vertical, the water flow 0.07L/min per hole, the duration time is 10min.

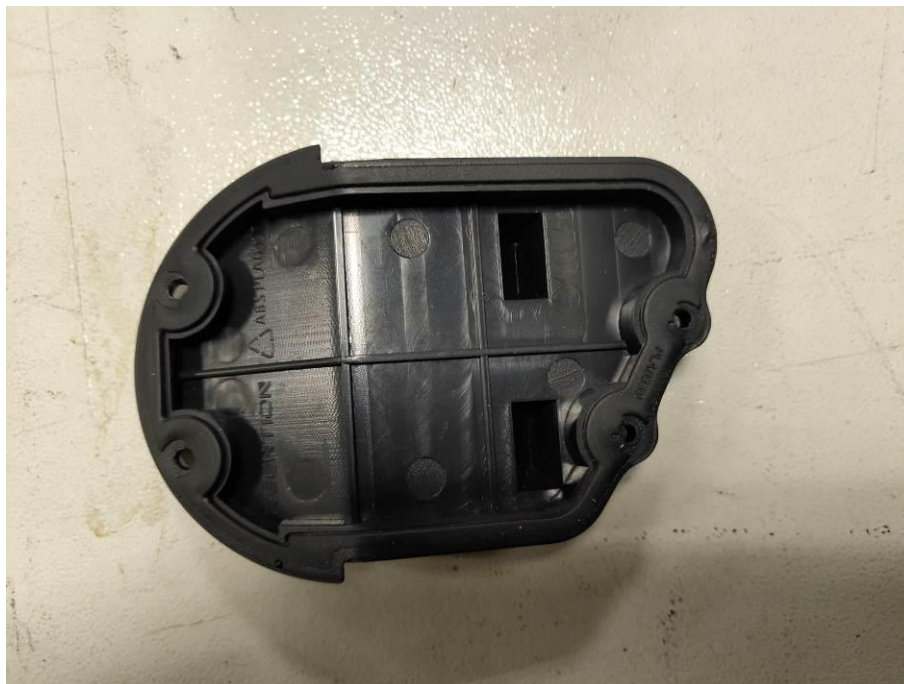
After test-1

There was no water in the sample after test.

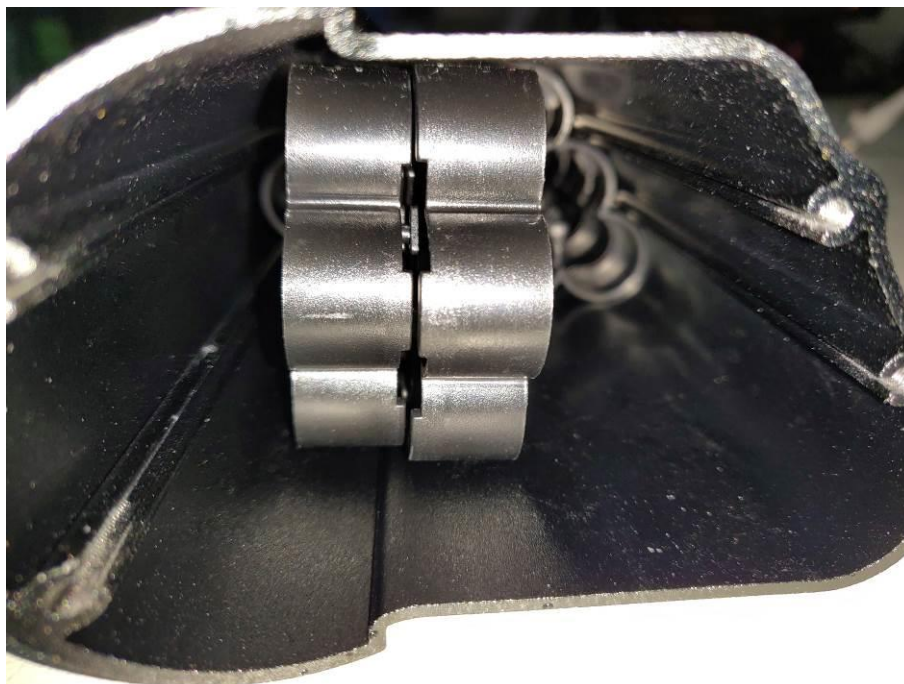
After test-2
